## **Animal welfare study report – CVE solar power plant in Bissey-sous-Cruchaud**

**Study conducted jointly by Statkraft, CVE and INRAE to assess the effects of the presence of photovoltaic panels on sheep grazing over a period of two years (2022-2023).**

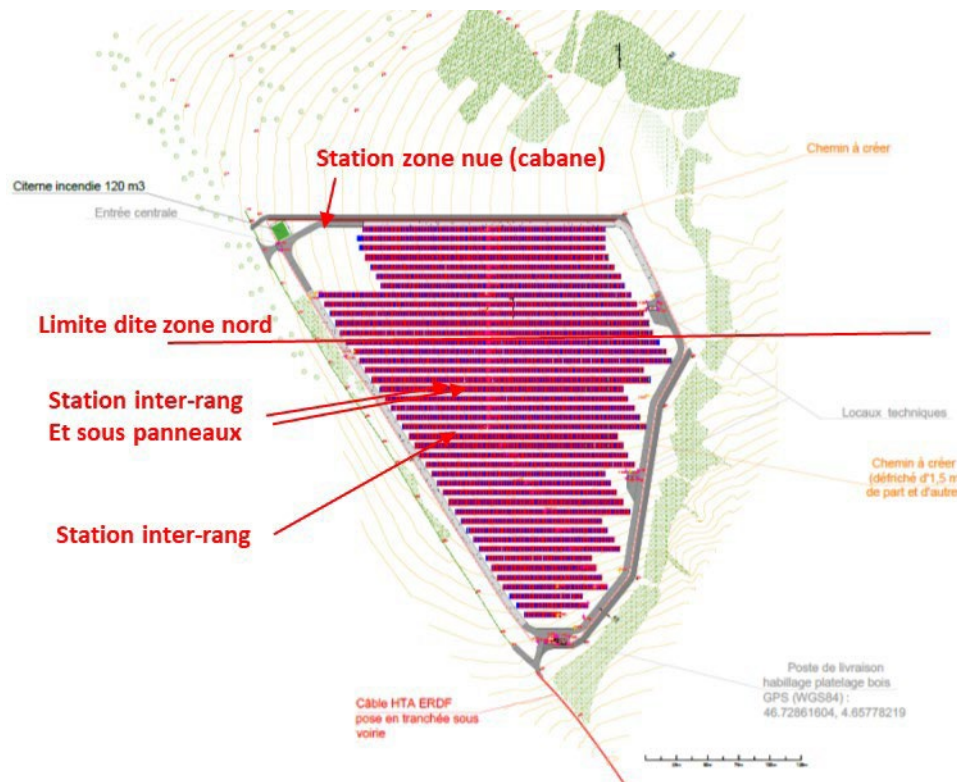
4 weather stations (Besser), recording hourly averages of temperature, humidity and wind speed were installed in the plant at 1 meter at ground level. 1 station was located in a bare area, 1 under a row of panels and the other 2 in the inter-row (see map below).

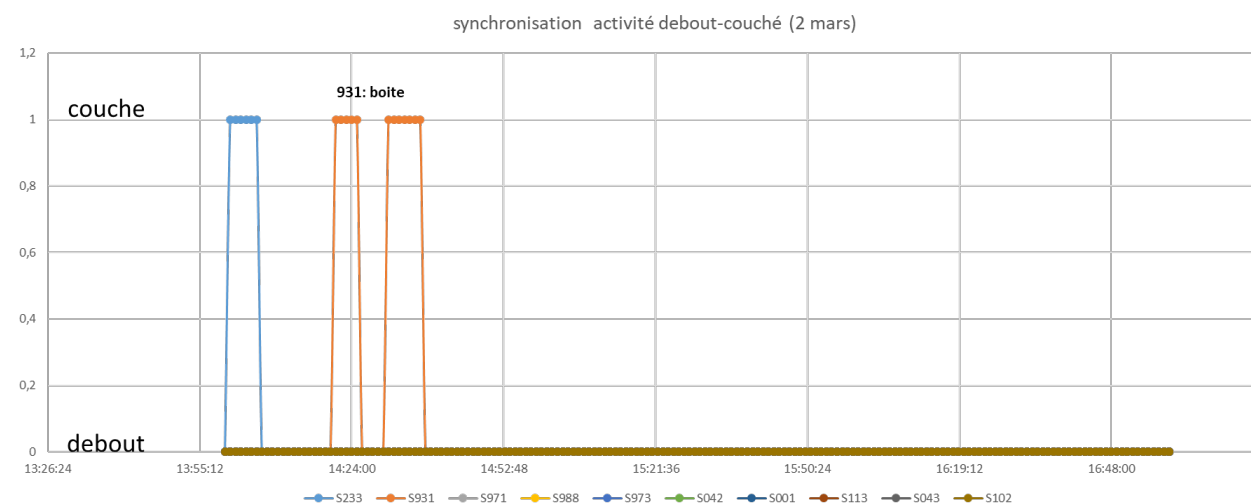
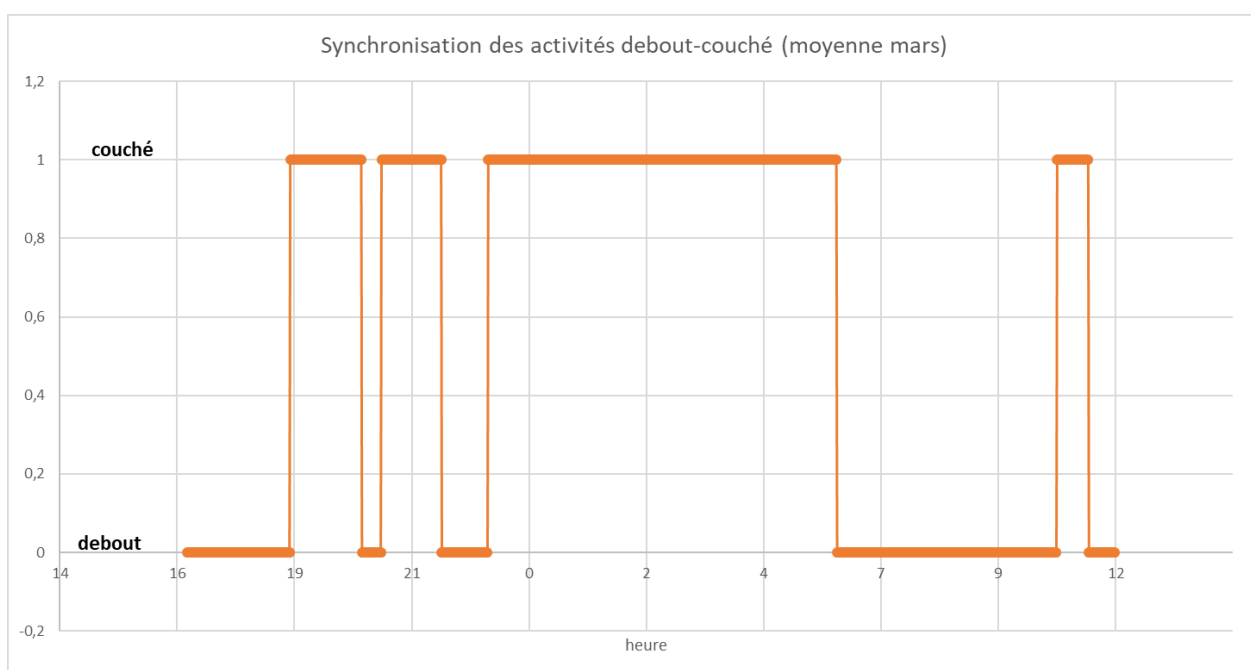
The 2 graphs below show that the activity (standing-lying down) is synchronized at the herd level. The ewes are up around 6 a.m. until 7 p.m. with a period of rest, lying down, around 11 a.m. Behavioural observations show that during this period the ewes graze or ruminate. From 11 p.m. to 6 a.m., the ewes are laid to rest. Only one ewe (no. 931) is out of sync with the flock during the day. This ewe had a lameness, which may explain this behavior. The pain induced by lameness forces the animal to change position more often than a painless animal.

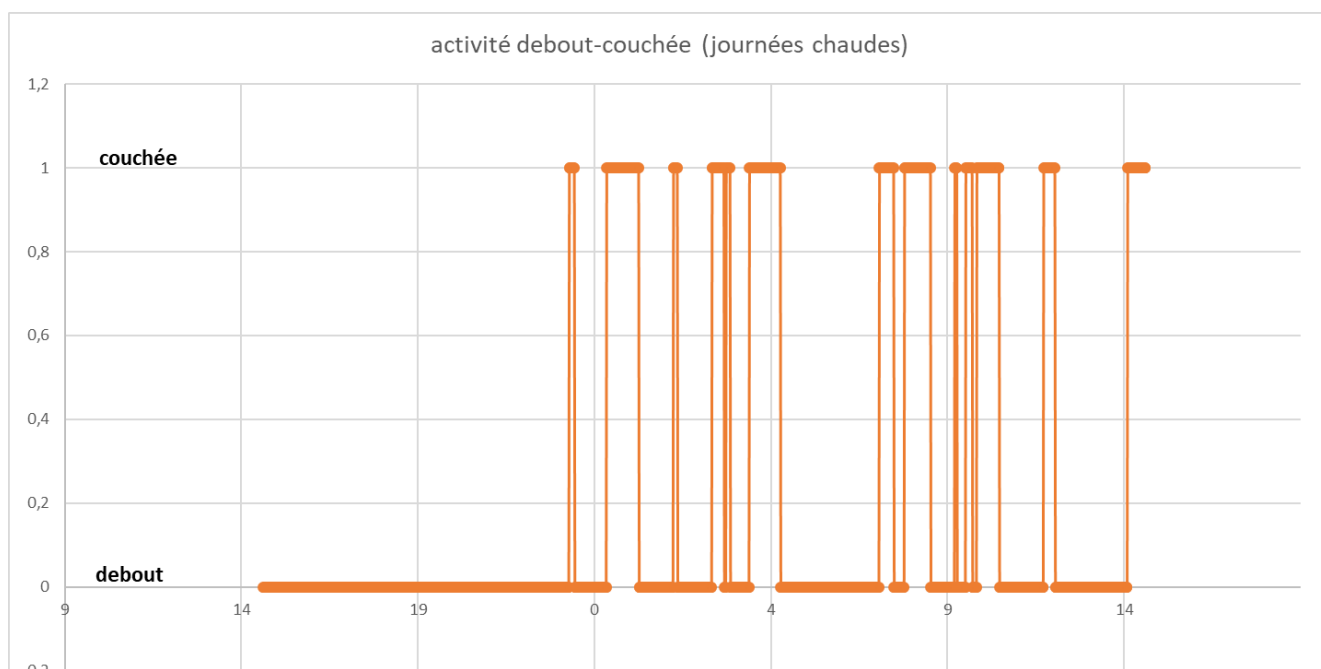
On hot days (below at the end of May 2022, a particularly hot period), the ewes are in a standing position earlier in the morning (5 a.m.) and lying down later (11 p.m.). Their standing-lying activity is more alternating than in cooler periods but remains synchronized at the herd level.

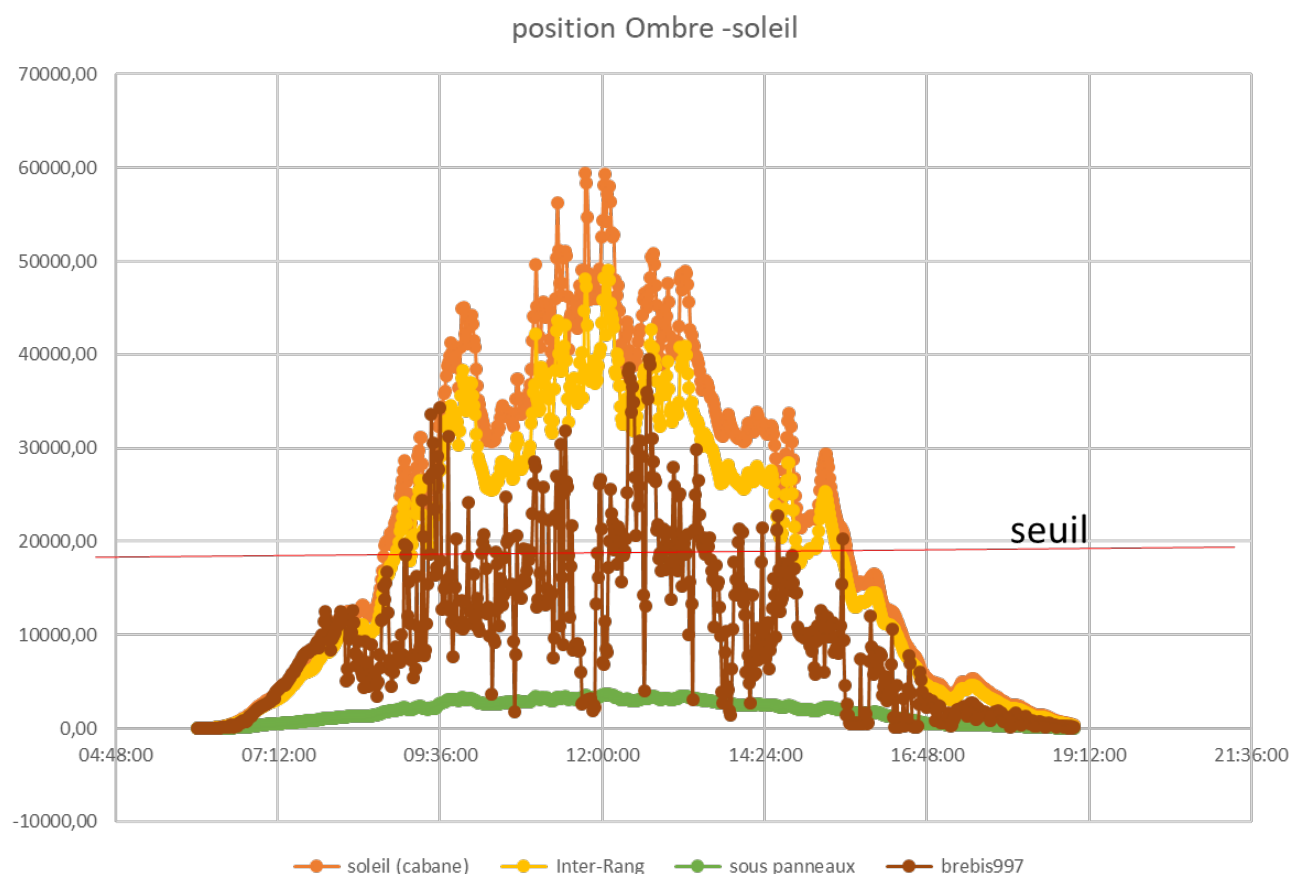
Behavioural observations (position in the bare area or under panels) made it possible to define a brightness threshold recorded by the sensors attached to the ewes which is 17,000 lux above the value recorded by the sensor positioned under the panels. This difference is linked to the fact that the sensor placed on the ewes does not have a fixed angle, it varies with the position of the ewes unlike the sensor positioned under the panels.

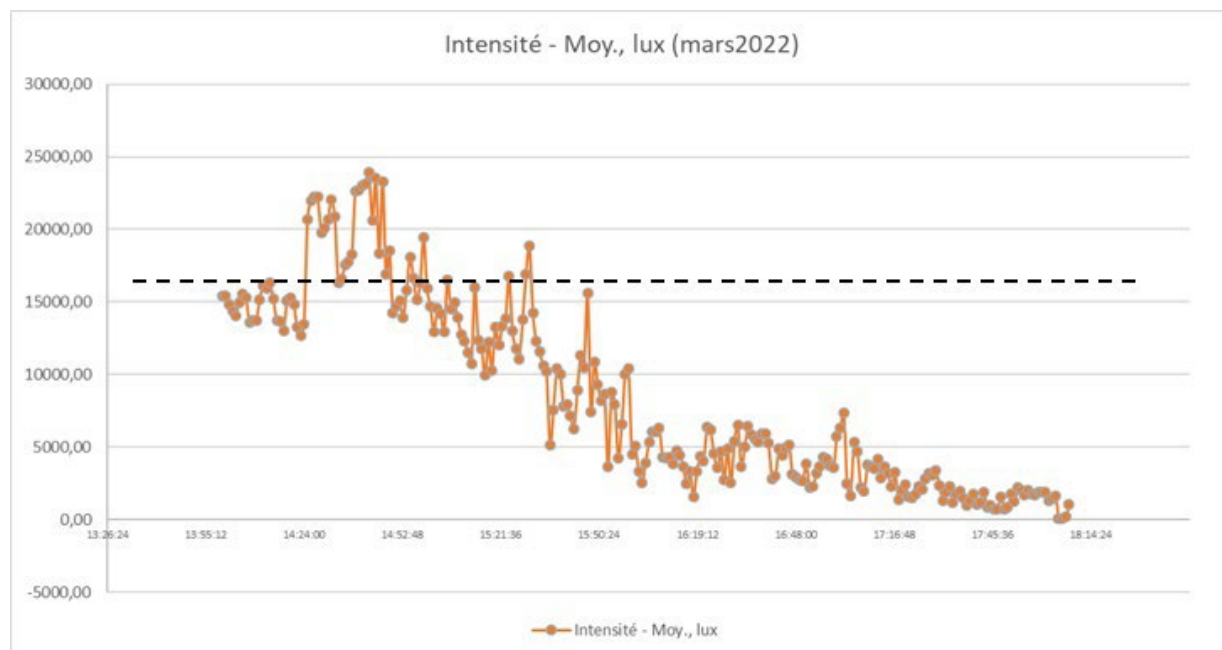
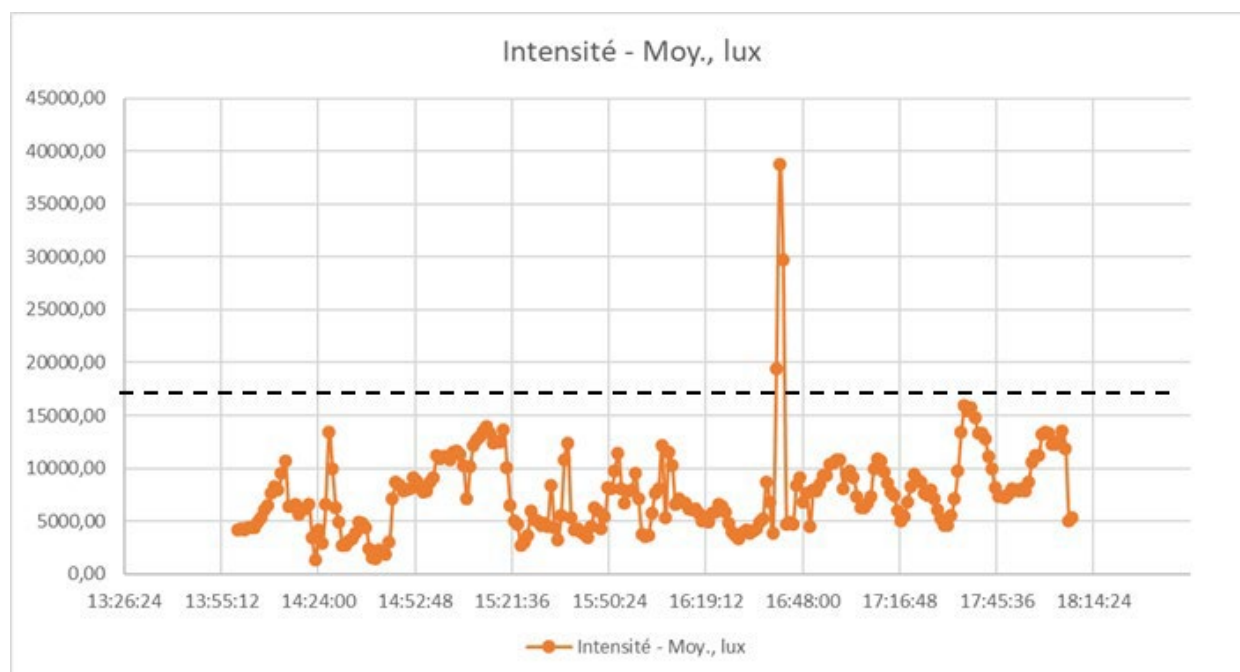
In March 2022 (graph above), ewes in the afternoon are in the bare area. On the other hand, in July 2023 (graph below) they remain in the shade under the signs in the afternoon.

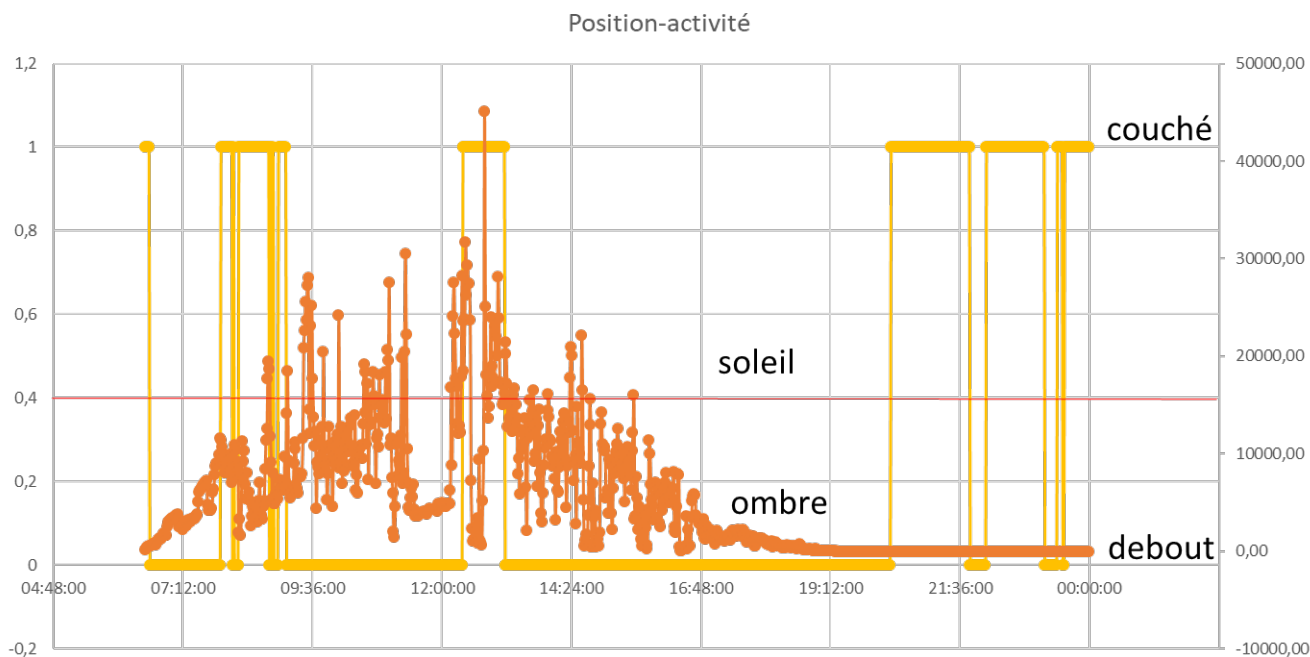
Over 90 days of data acquisition (loss of sensors), it was possible to couple the data acquired by pedometers and lux meters. In early spring and fall, there is no standing-lying activity associated with a shade-sun position. On the other hand, in late spring and summer (graph below), standing activity, including ingestion activity, is associated with a position in the shade.

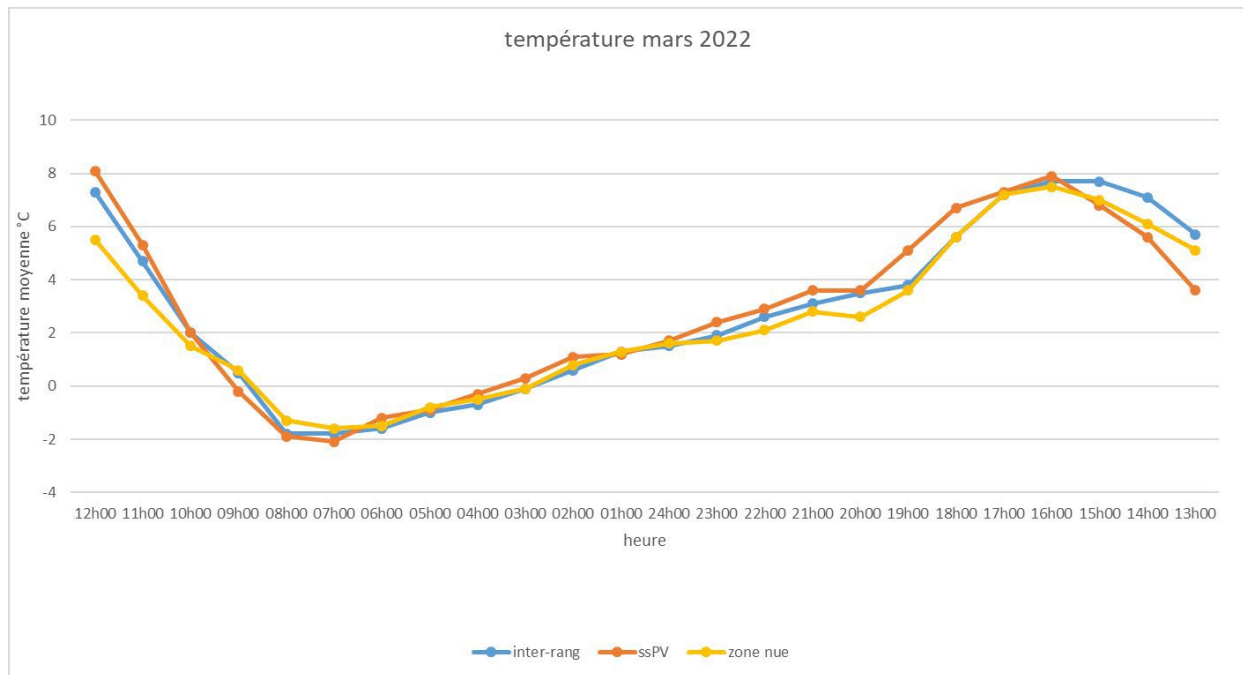
During the night (6 p.m. to 6 a.m.) the temperatures, cumulatively, under signs are slightly higher than those recorded between rows and in bare areas. From 10 a.m. to 12 p.m., the temperatures under the panels are higher than those recorded in the bare area, then there is an inversion in the early afternoon.

Average hourly temperatures over the 10th days of March 2022 (Note : The data recorded at the 2 stations in inter-row, not being significantly different, were averaged.)

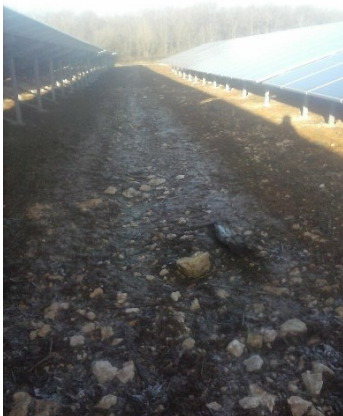
Occasionally, it was noted that at the end of winter in the morning around 8 a.m. the ground was covered with white frost between the rows but not under the signs, even if they were still in the shade.

The higher cumulative temperatures during the night under the panels than between the rows may explain the absence of frost under the panels at the end of winter.

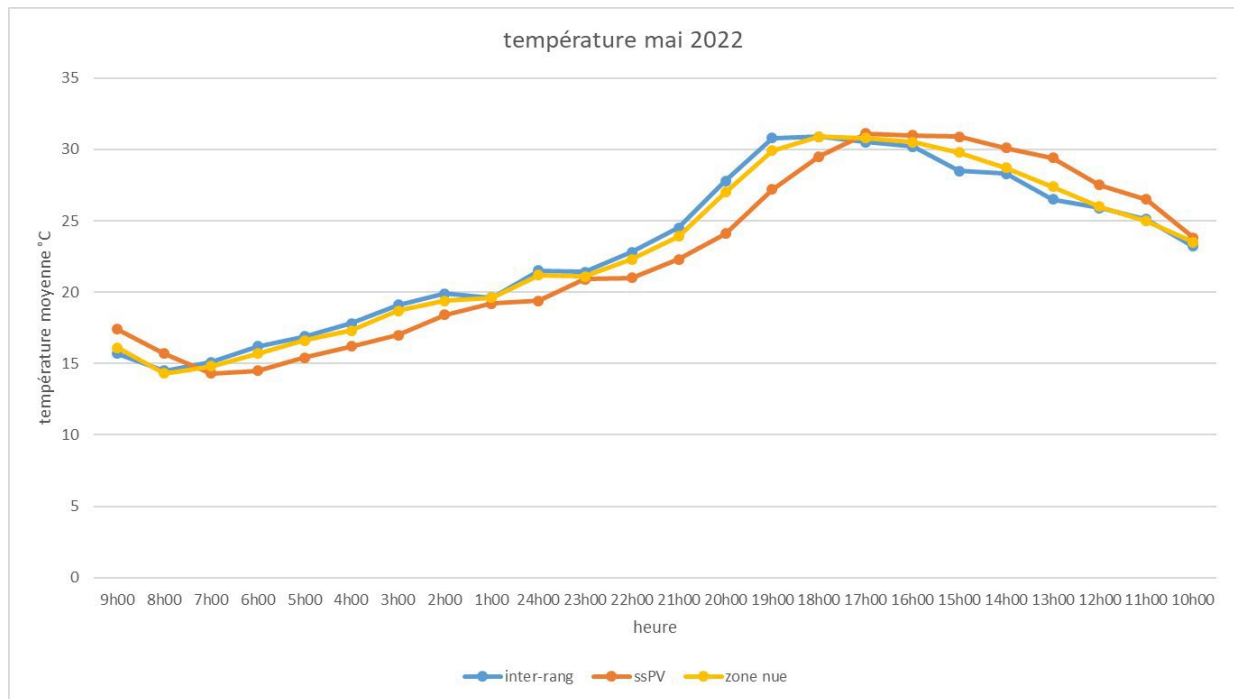
In May 2022, temperatures between rows and in bare areas are never significantly different. During the night, temperatures under the panels are lower than those in the inter-row and bare area. There is an inversion between 11 a.m. and 3 p.m., a period during which the temperatures under the panels are higher than elsewhere in the plant.

Average hourly temperatures over the 10th days of May 2022

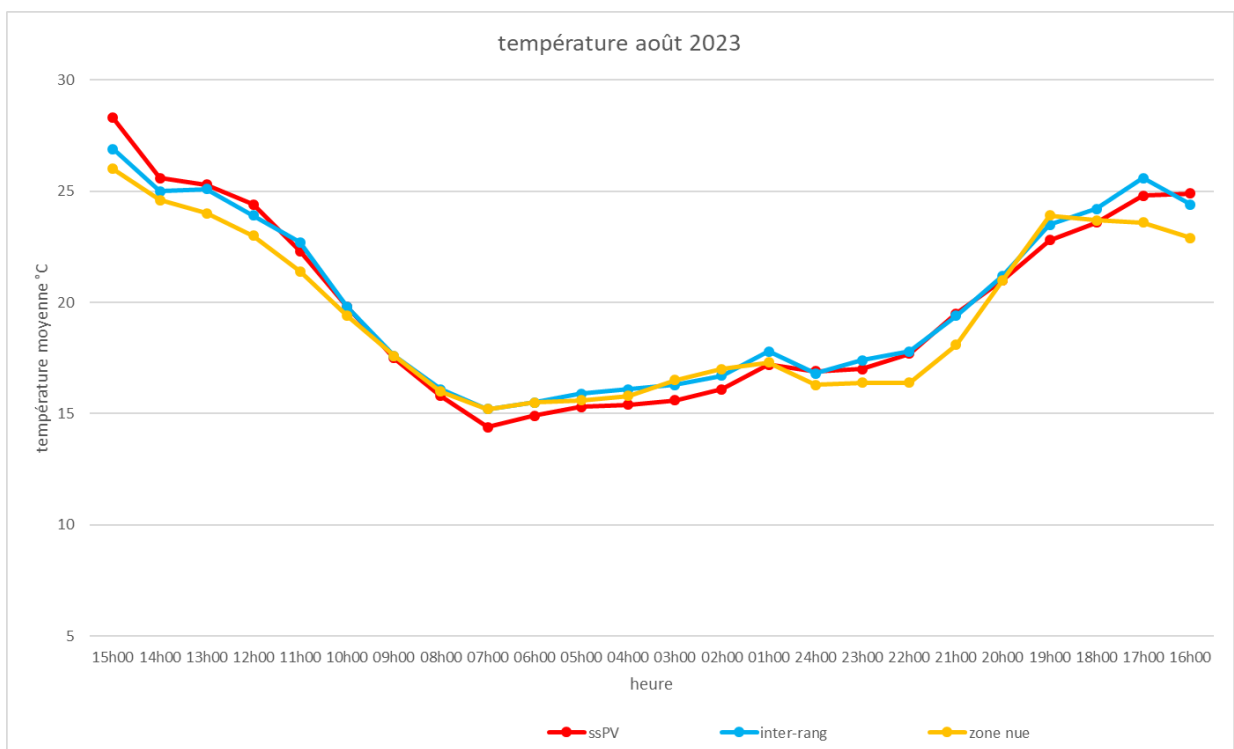
In August 2023, there is no significant difference between the temperatures under the panels and between the rows. Cumulative temperatures are lower in the bare area at 11 a.m. and 11 p.m. than under the signs and between rows.

Average hourly temperatures over the 10th days of August 2023

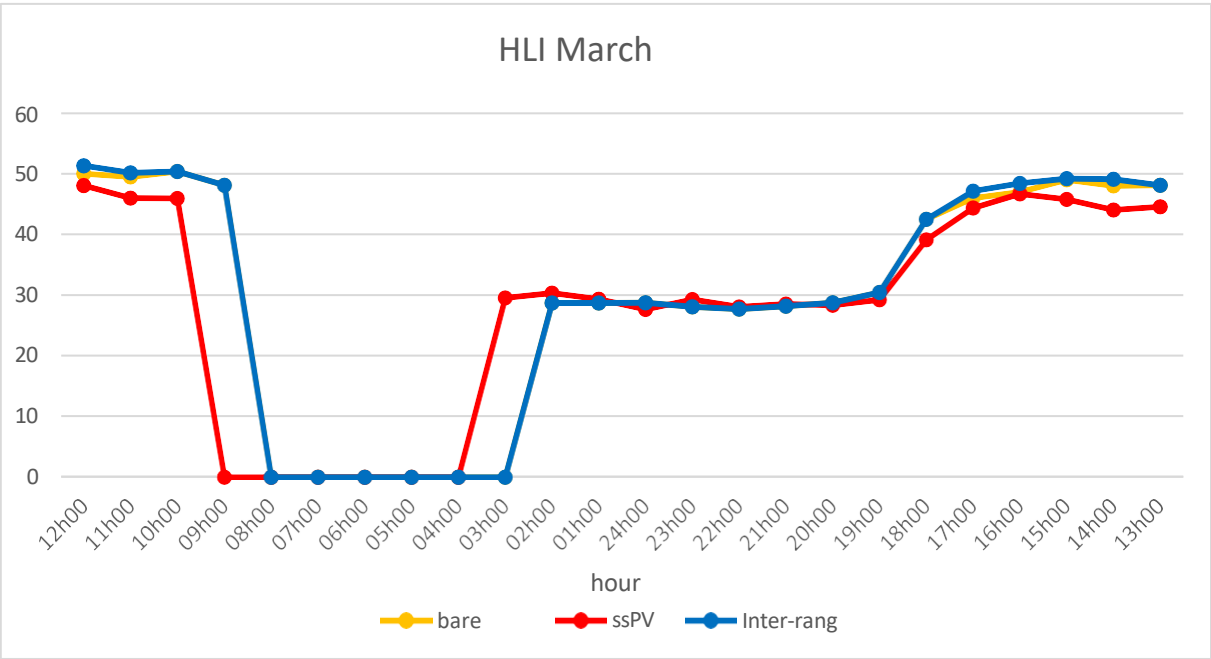
The following 3 graphs represent the thermal feeling perceived by ewes (HLI). Although the temperature under the panels was sometimes higher than in other areas of the plant, the HLI under the panels is still lower. The lower levels of solar radiation under the panels explain these lower HLI values. In May (5 p.m.), however, an HLI under signs was recorded

Average hourly HLI on the 10th days of March (HLI=0 means that temperatures were negative)

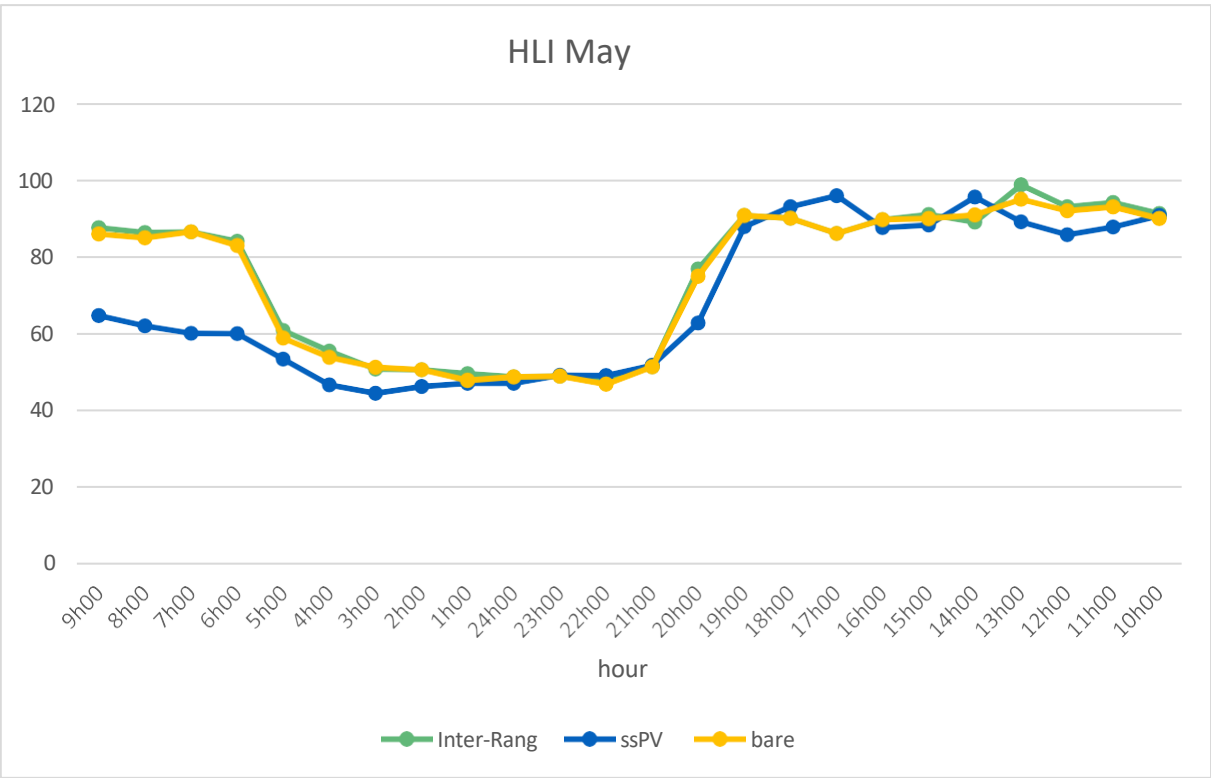
In May, from 10 a.m. to 7 p.m., the HLI indicates marked stress regardless of the location of the plant. From 6 a.m. to 9 a.m., the HLI indicates an absence of thermal stress under the panels, while the other places in the plant induce moderate stress.

Average hourly HLI on the 10th day of May

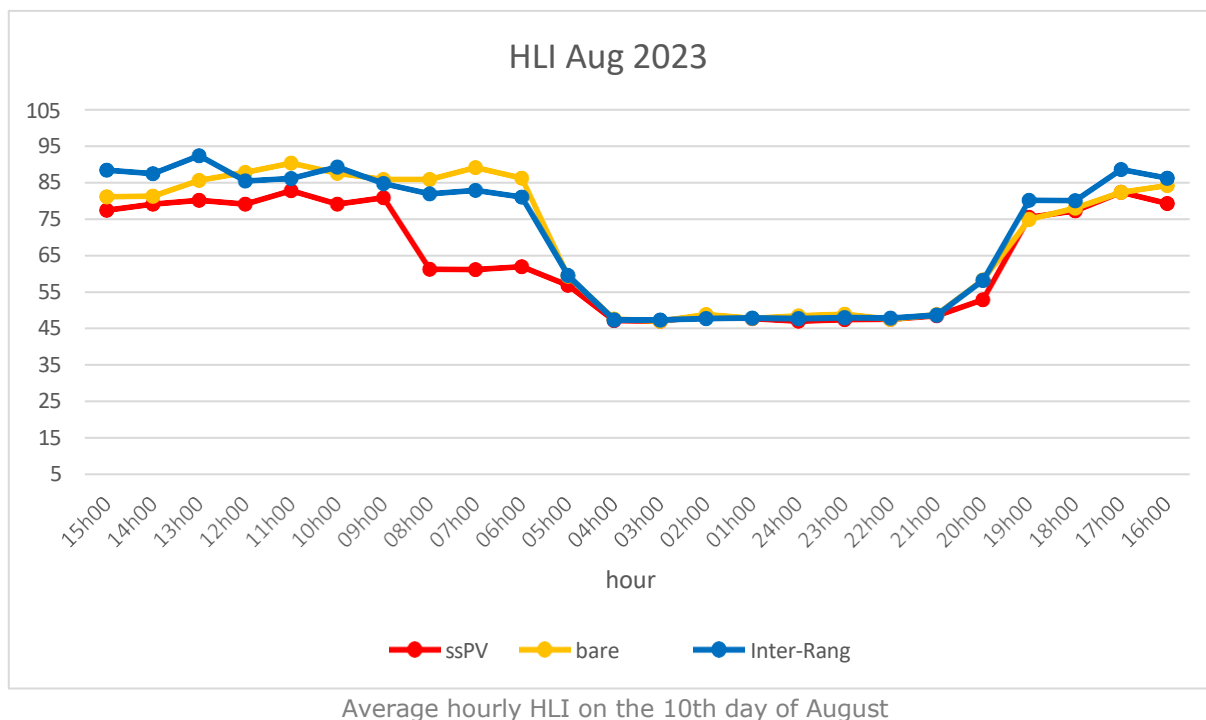
In August, from 10 a.m. to 5 p.m., the HLI indicates a marked state of stress in the inter-row or bare area, while under the signs the moderate stress stage is never exceeded.

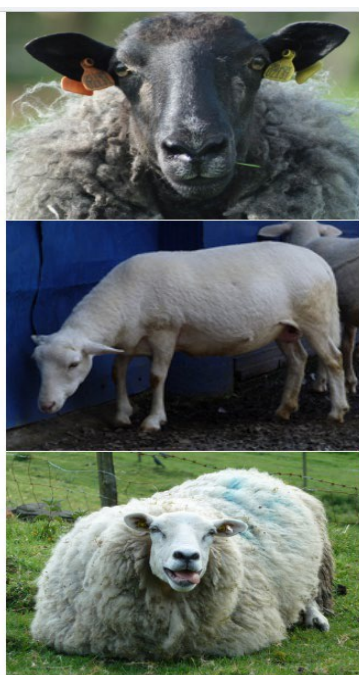
**Normal:** Breathing is at a normal rate (about 20 breaths per minute), with the mouth closed.

**Medium stress:** The respiratory rate is greater than 30 breaths per minute but less than 40 and the breathing is done with the mouth closed.

**Panting, high stress:** The respiratory rate is greater than 40 breaths per minute and/or occurs with the mouth open.

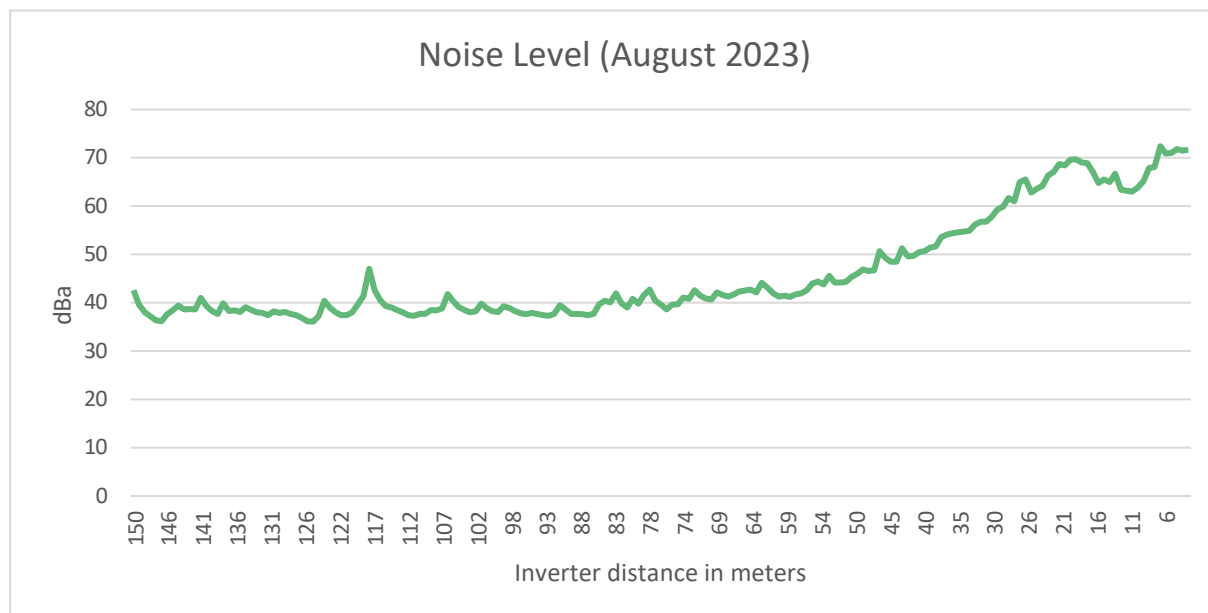
The noise level, when the panels were in operation, gradually increased in dBa between the edge of the plant and the inverters located in the middle of the panel row.

Sound atmosphere recorded in the inter-row in August 2023 at 1 p.m. from the edge of the power plant to  
The inverter

In June 2023 at 1 p.m. the noise level recorded at 1 meter from the inverter was 71 dBa, in August it was 72.4 dBa and in October it was 61.5 dBa.

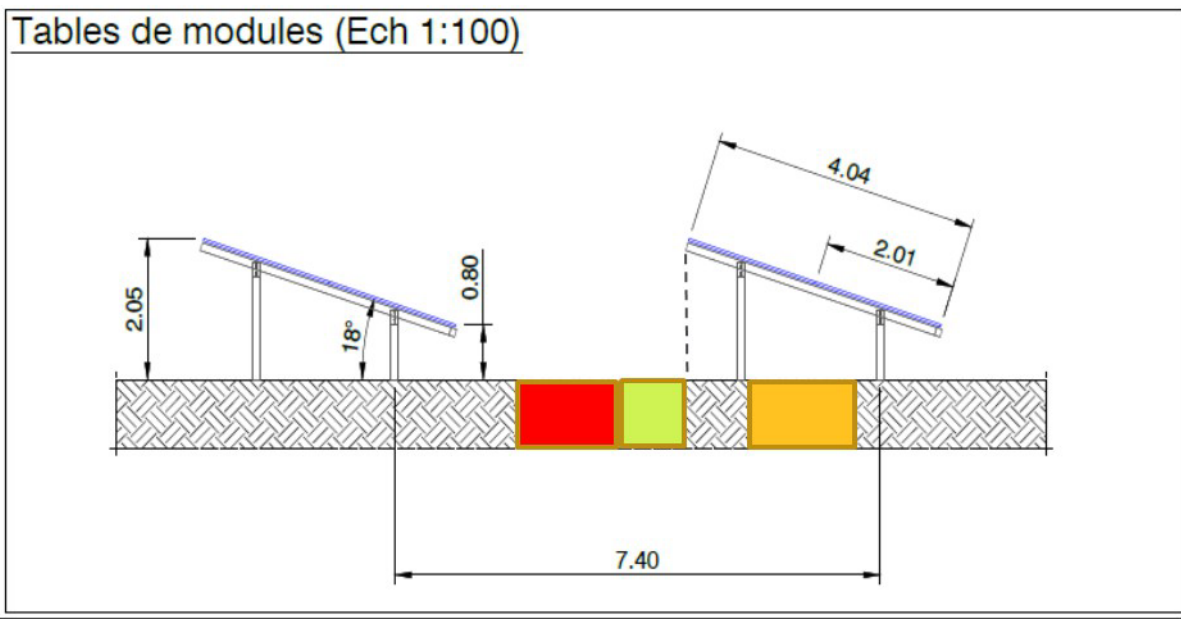
Grass height measurements carried out in June 2023 in grazed areas show a gradient between the inter-row and under the panels (see diagram below). The average height between the rows was 2cm (red area), 3 cm below the panels (orange area) and 7cm to 1m from the upper part of the panels (green area).

(based on Statkraft-CVE schematic)

In June 2023, grass heights were measured in grazed areas with a herbometer. 100 measurement points were made under the panels, 100 others between rows and 100 others 1 metre from the upper part of the panels (see diagram, results section).
